CASE STUDY: CLEANING STUDY ASSISTS AUSTRALIAN CONSOLIDATED MILK RECLAIM THEIR WATER PLANT CAPACITY

FOULING INVESTIGATION

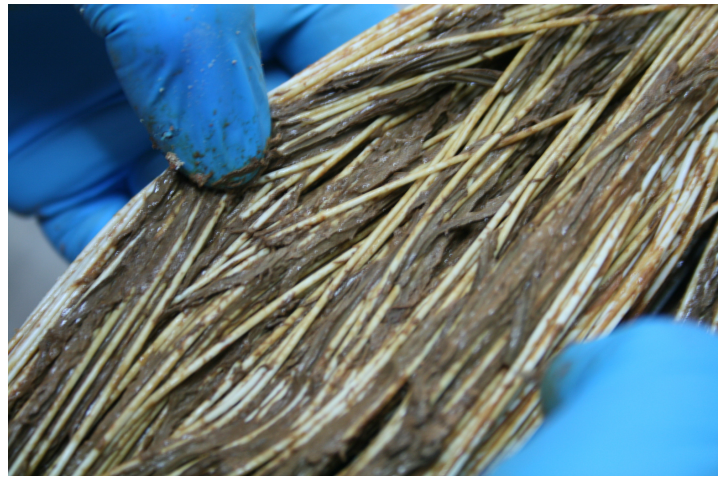
Our first step was to conduct an autopsy of the membranes. Upon opening the membranes, we noted a heavy fouling around the top and bottom of the module, but limited fouling in the high flow areas. This showed that the Chemically Enhanced Backwash (CEB) and flushing cycles were not completely cleaning the membranes. The fouling was a mix of organic bacterial slime (EPS), alumino-silicate clays and precipitated iron.

Heavy silt, iron and biological fouling.

Initially, ACM implemented a range of cleaning improvements, including the use of hot Clean In Place (CIP) procedures to remove organic deposits and sodium metabisulphite to remove accumulated iron fouling. They also increased the flush volumes, to ensure that any loosened deposits are completely removed from the membrane before they are put back into operation.

The site is now installing a coagulant dosing system to better remove aluminium and iron before they reach the membrane system.

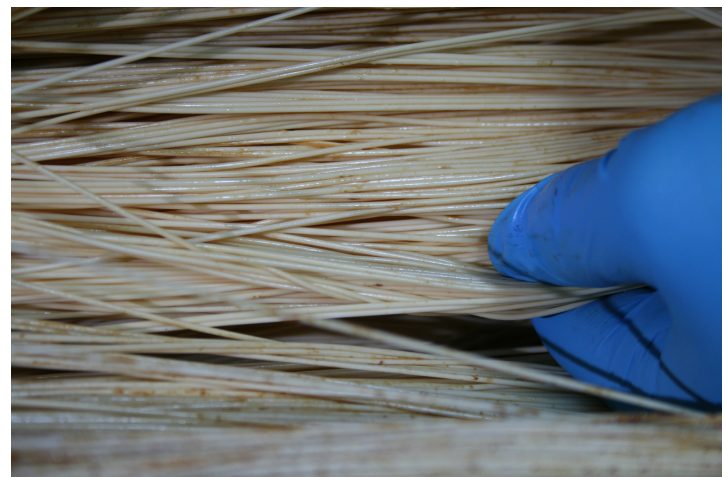
Clean areas in CEB cleaned zones

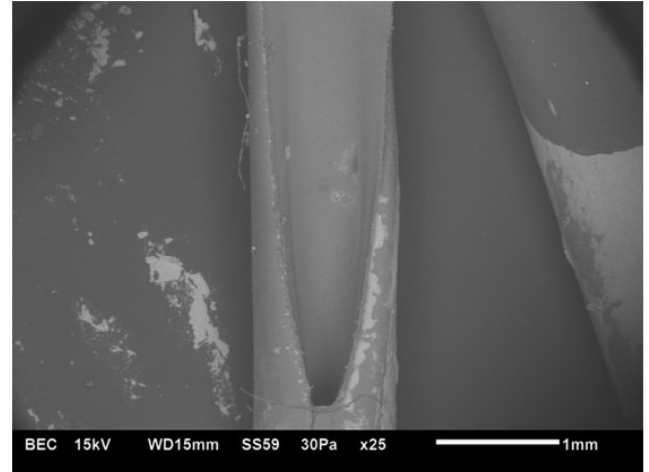
Electron microscope image of hollow fibre showing clear interior

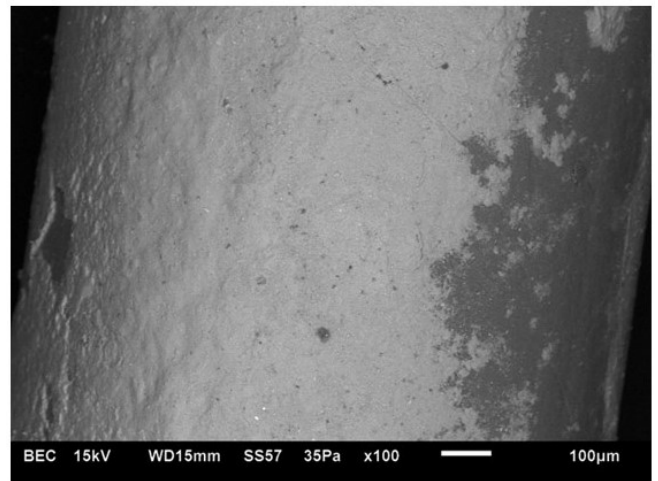
Electron microscope image of hollow fibre showing clay coating the exterior of the membrane fibre
